## Research on fire safety of industrial flat roofs with PV installations

Report no.	2021-Efectis-R001109[Rev.2](E)
Sponsor	Stybenex Kerkstraat 14 4191 AB GELDERMALSEN
Prepared by	Efectis Nederland BV
Author(s)	M.P. de Feijter, B.Sc. T.G. van der Waart van Gulik, M.Sc.
Project no.	ENL-21-000009
Date of issue	August 2023
Number of pages	23

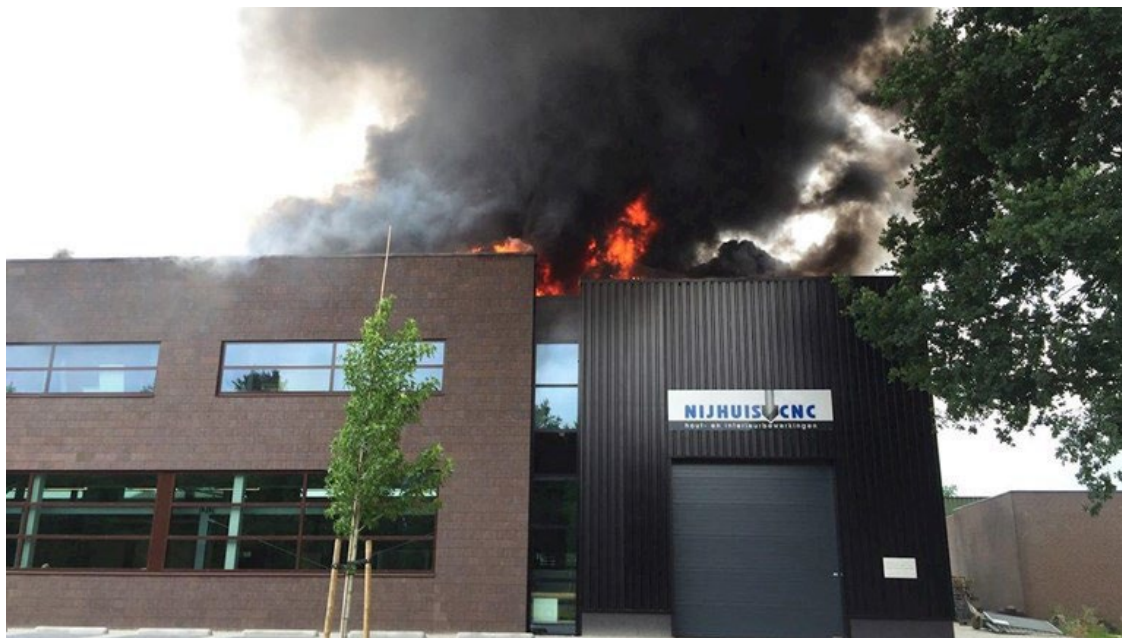
Figure 1 Fire on the roof (source: [www.rtvooost.nl](http://www.rtvooost.nl))

Whether there was an intermediate layer between insulation and roofing is not known. The photograph does not show any glass fibre interlayer. The fire class of the roof and whether the roof was flammable according to NEN 6063 is not known.

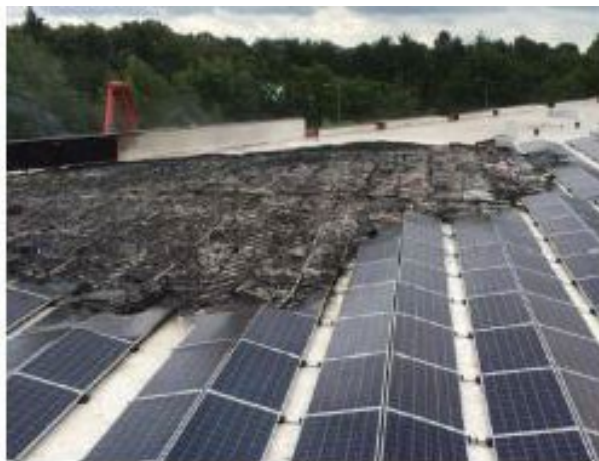
Figure 2 Overview of damage on the roof (source: unknown)

Based on the images of the damage, the fire does not appear to have spread beyond an area about 4 metres from the solar panels.

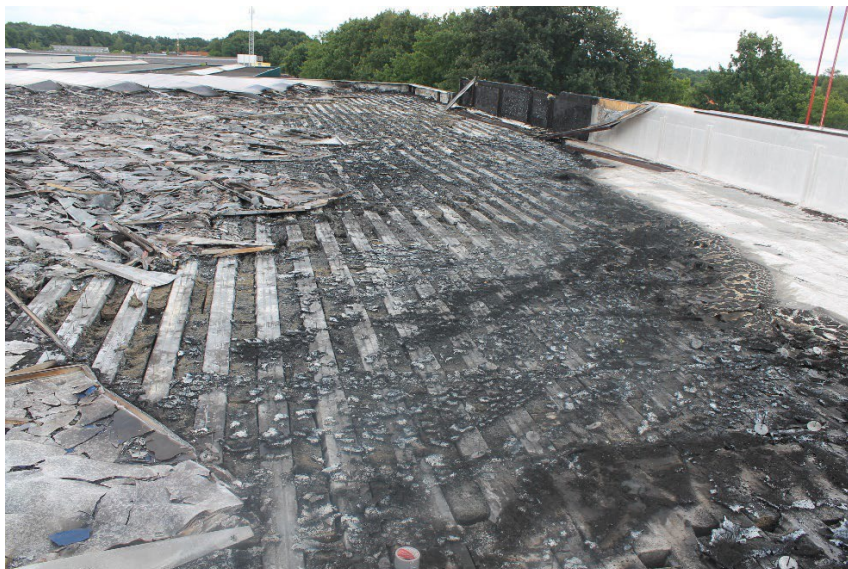
Figure 3 Damage to the roof (source: Fire brigade Twente)

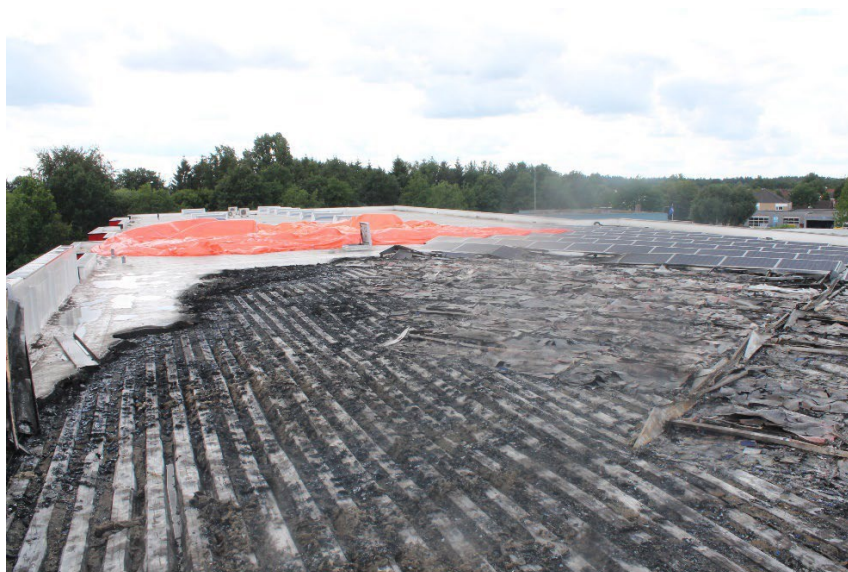
Figure 4 The fire has been stopped before the fire separation (at the location of the tarpaulin on the roof) (source: Fire brigade Twente)

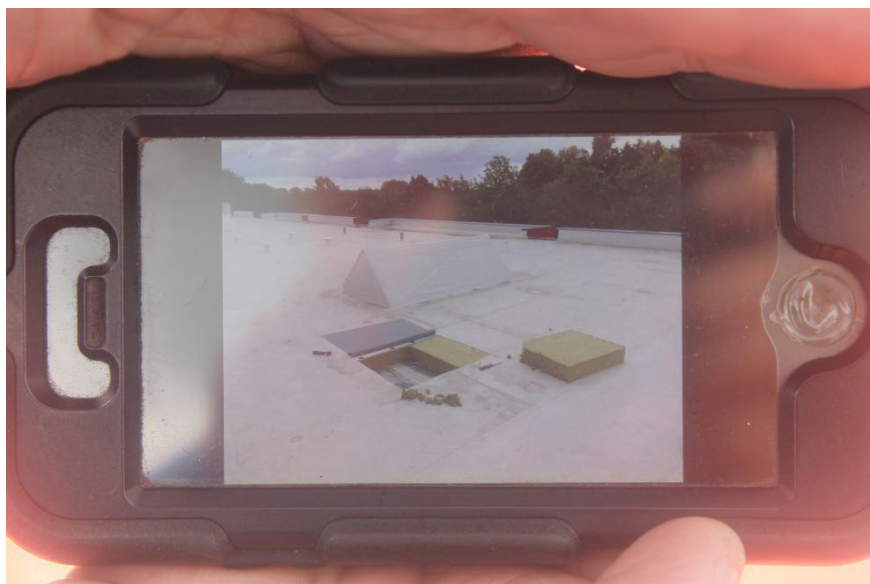
Figure 5 The roof is interrupted at the fire-resistant partitions with rock wool, but not covered with a layer of concrete tiles (source: Fire Department Twente)

If a perforated roof sheet is used, Efectis recommends that a barrier be provided to create a fire-resistant roof and to prevent the spread of fire to the interior. This could be a flameproof plate between the solar panels and the roof or a fireproof covering on the underside of the insulation or on the underside of the roofing sheet.

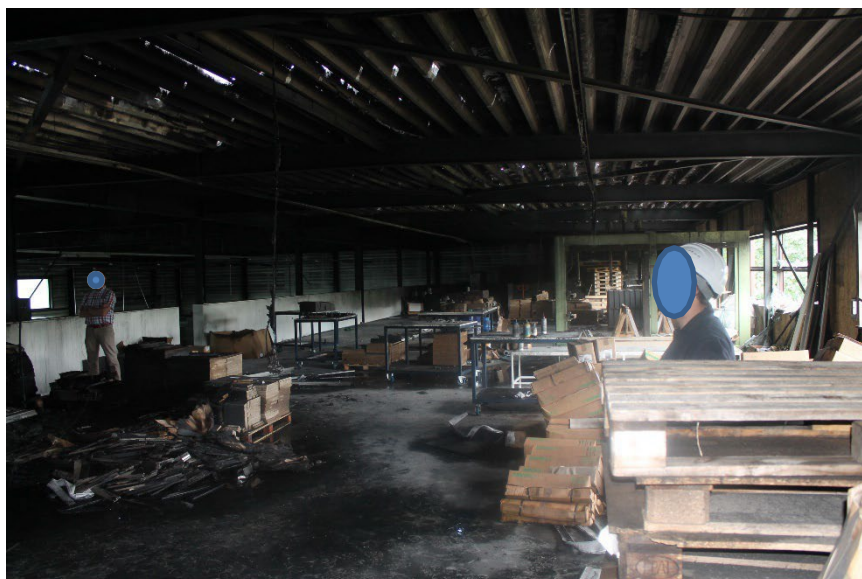
A secondary fire started in the building as a result of falling burning material (the Fire Service states that the fire spread was caused by burning, dripping EPS). If the rockwool cannelure filling is wrapped in HDPE foil, it cannot be ruled out that this foil could have caused the fire to spread through the holes in the roof by burning droplets.

Figure 6 Secondary fire in the building caused by burning falling material (source: Fire brigade Twente)

The fire in Denekamp is the only fire where fire spread to the inside of the building took place as a result of burning dripping materials through the perforated roof sheet. The fire service states that the fire spread is the result of burning, dripping EPS.

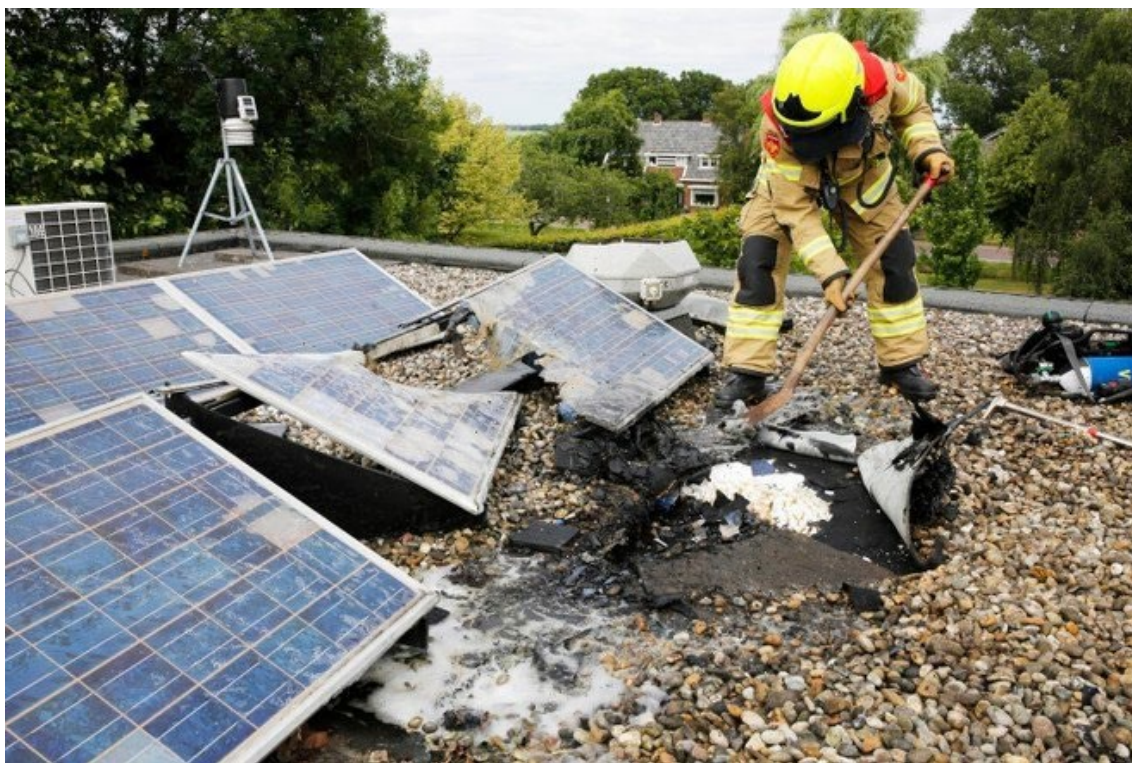
The fire was limited to two solar panels. The bituminous roof covering also started to burn and the photos show that the EPS insulation had melted, evaporated or burned away over an area of roughly 40x40 cm (estimate based on photo). Where there is gravel ballast on the roof, the fire did not spread.

Figure 7 Fire on roof of Opmeer town hall (source: [www.noordhollandsdagblad.nl](http://www.noordhollandsdagblad.nl))

Where a roof is fitted with ballast gravel, Efectis recommends that the gravel, or alternatively concrete tiles, should also be laid under the solar panels in order to prevent the roofing material from catching fire and thus to limit further fire development.

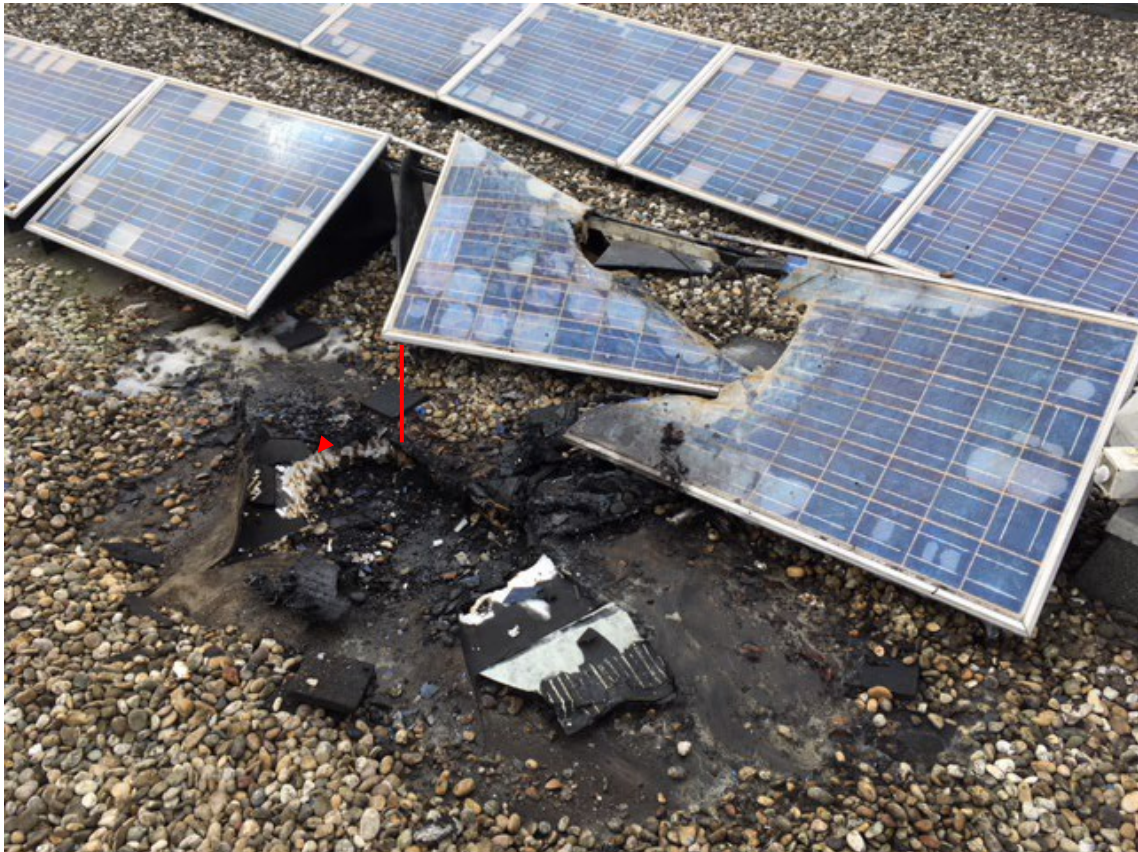
The fire started in a solar panel. Traces of overheating were found in several places in the solar panels. Based on the photos, part of the supporting structure of the solar panels appears to be made of plastic and these parts participated in the combustion.

Figure 8 Damage to solar panels and roof. Melted EPS is visible in the red arrow. Characteristic "caramelised drops" (source: Municipality of Opmeer)

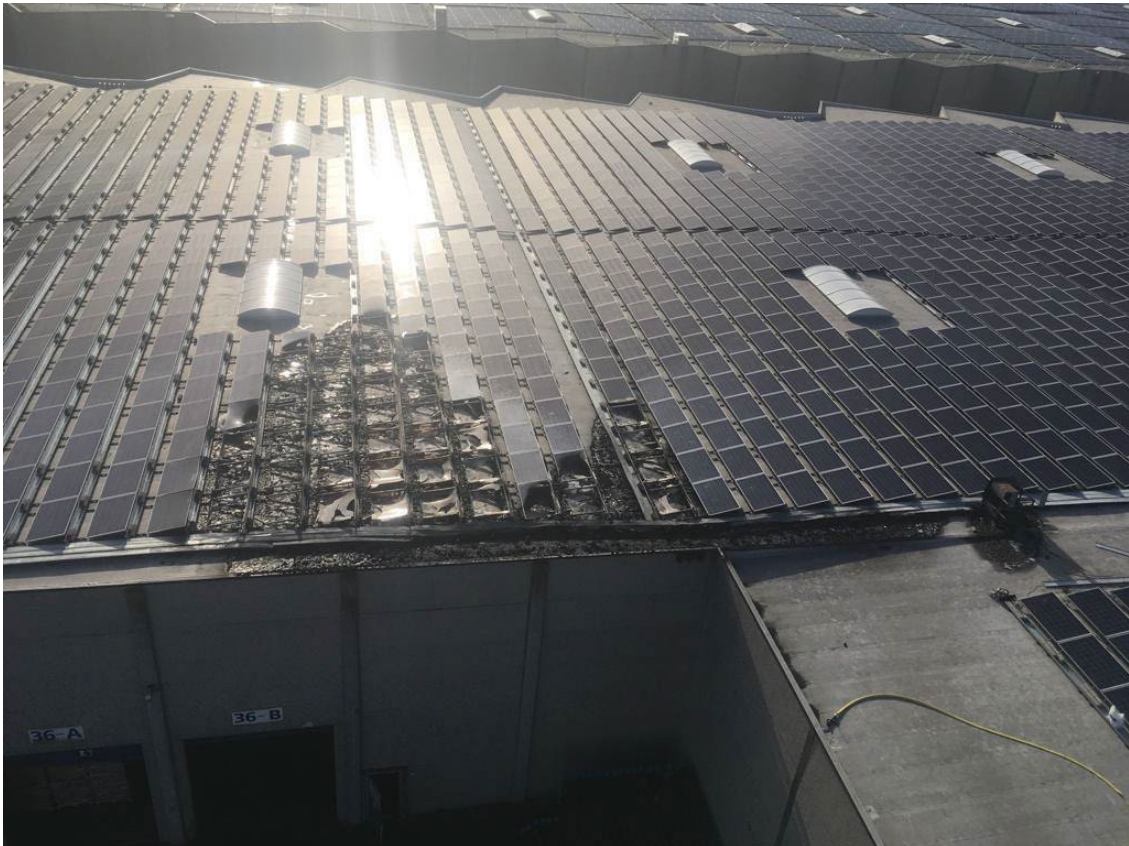
The fire started in a switch box that had fallen over prior to the fire. The fire damage is limited to an area next to the switch box, along the cable duct and at the location of the solar panels involved in the fire. The fire did not spread further across the roof or inwards.

Figure 9 Damage on the roof of the storage hall (source: Amsterdam-Amstelland Fire Service)

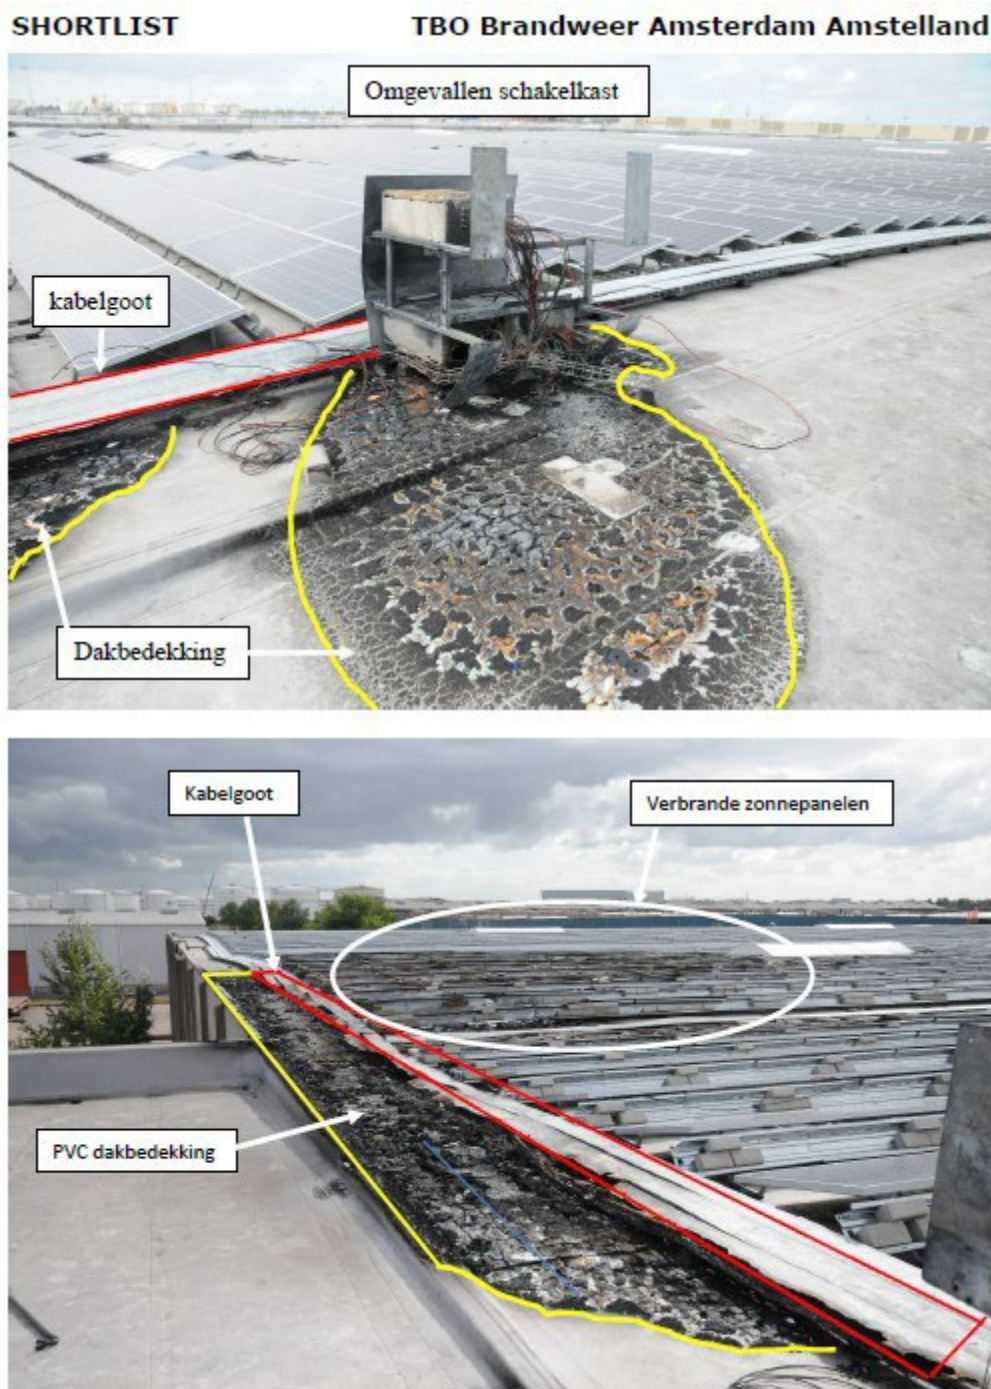
The fire spread from the switch cabinet via the cable duct to the solar panels. This corresponds to the normal fire behaviour in an electrical installation. The fire is running in the direction of the power source (in this case, the solar panels) as a result of the repeated occurrence of electrical connections.

Figure 10 Damage next to the switch box and the cable duct (source: Amsterdam-Amstelland Fire Service)

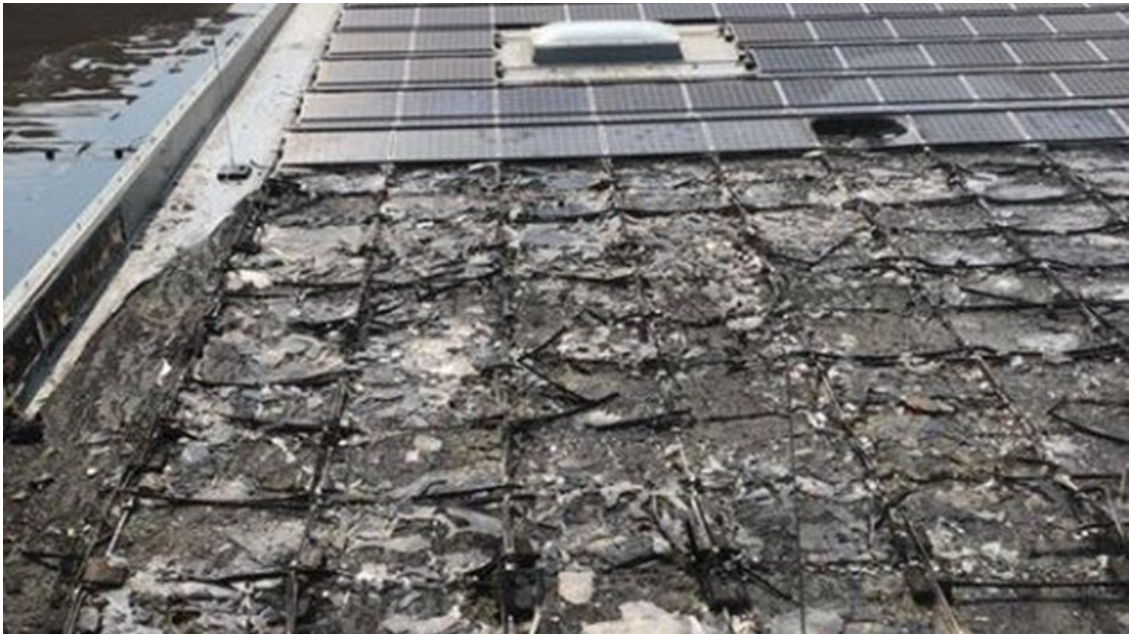
The only information about this fire received from the fire service was that rock wool insulation had been used in the roof. News reports on the internet only mention a fire on the roof without any internal spread. One of the photos available shows that a skylight melted as a result of the fire, but the fire had not yet penetrated the building.

Figure 11 Damage on the roof of Gazelle (source: [www.omroepgelderland.nl](http://www.omroepgelderland.nl))

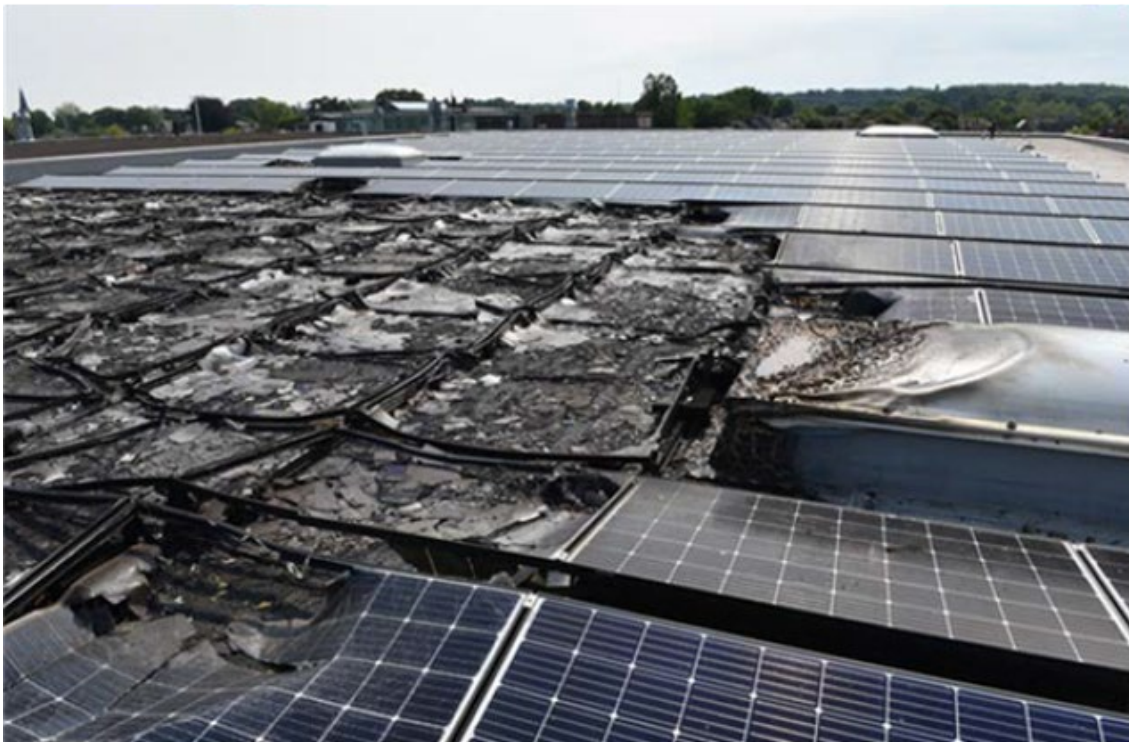
Figure 12 Damage on roof of Gazelle, where the fire reached a skylight (source: unknown).

### 4.2.2 Around roof lights and lead-throughs, Efectis recommends placing the solar panels at a sufficiently safe distance and preferably equipping lead-throughs with a fire-resistant device. Fire spread to other fire compartments

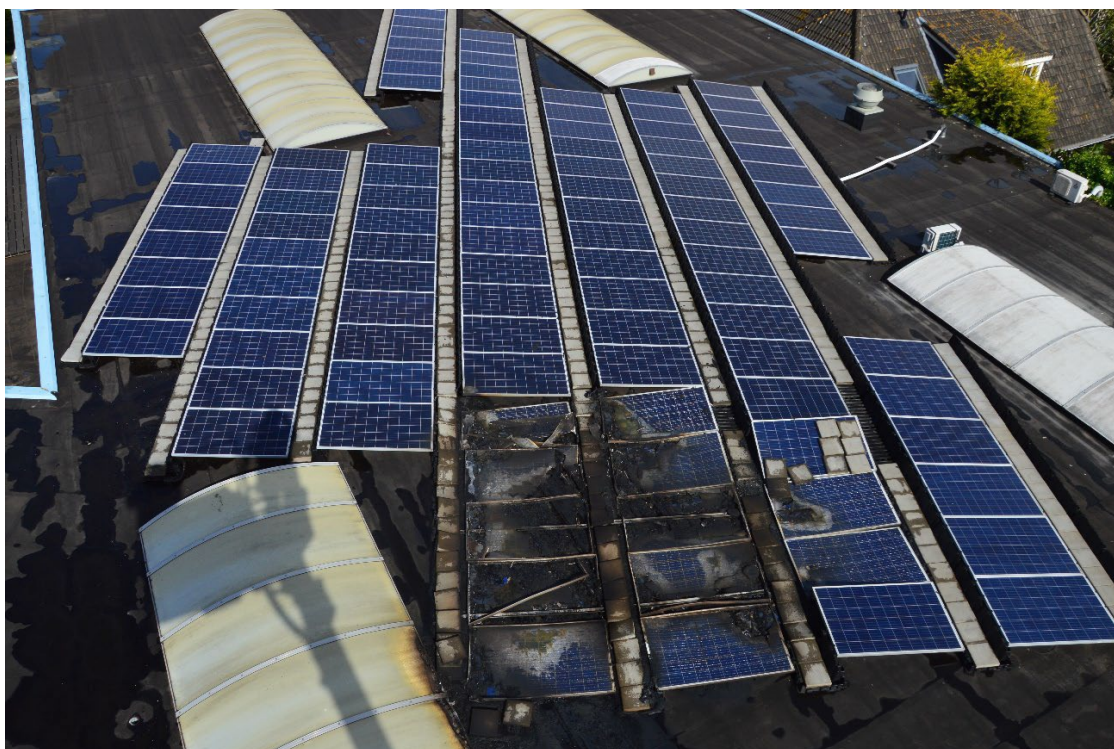
The fire started in a junction box under a solar panel (source: TBO Fire Brigade Haaglanden). The solar panels were placed on a plastic support structure (with concrete ballast tiles) that contributed to the fire development. Leaves and cabling were underneath the solar panels, which contributed to the initial fire development. Subsequently, the bituminous roofing started to burn along with the EPS insulation.

Through cracks in the roof construction, it was observed that the fire moved between the roof plate and the bitumen.

Figure 13 Damage on the roof (source: TBO Fire Department Haaglanden)

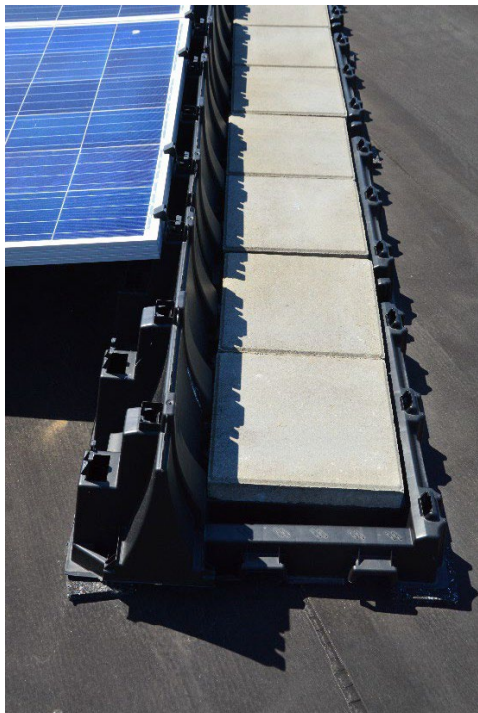
Figure 14 Plastic support structure

Many support structures have some plastic components which may contribute to the development of the fire. In the case of the fire in Wateringen, the support structure was made entirely of plastic. It is not known what type of plastic was used and whether this construction was tested for its fire behaviour. The images show that the plastic support structure did contribute to the development of the fire.

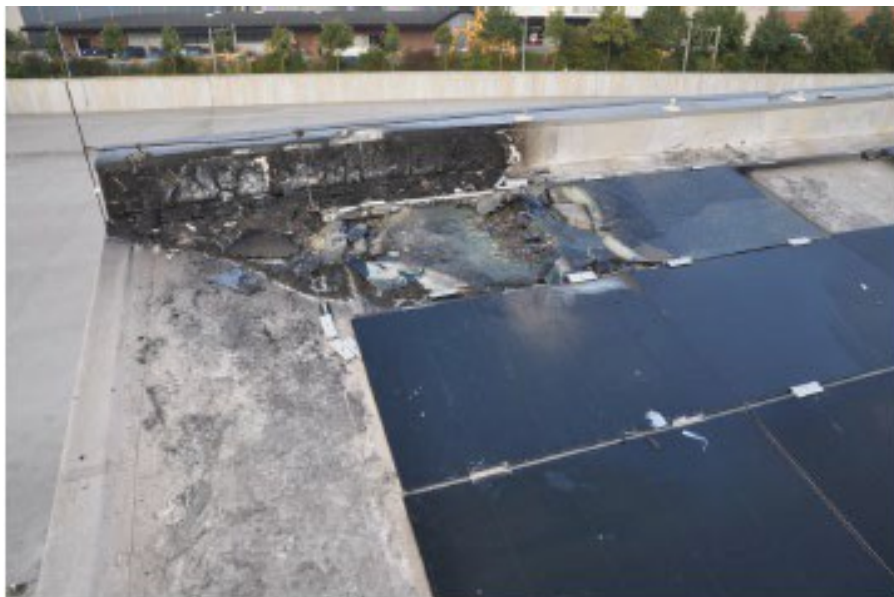
The fire was noticed by a passer-by, after which a successful extinguishing attempt was made with a hand-held fire extinguisher. The fire was limited to one solar panel.

The fire was able to spread along an upstanding roof edge, but did not reach the inside.

Figure 15 Fire damage limited to a few panels and a small part of the roof.

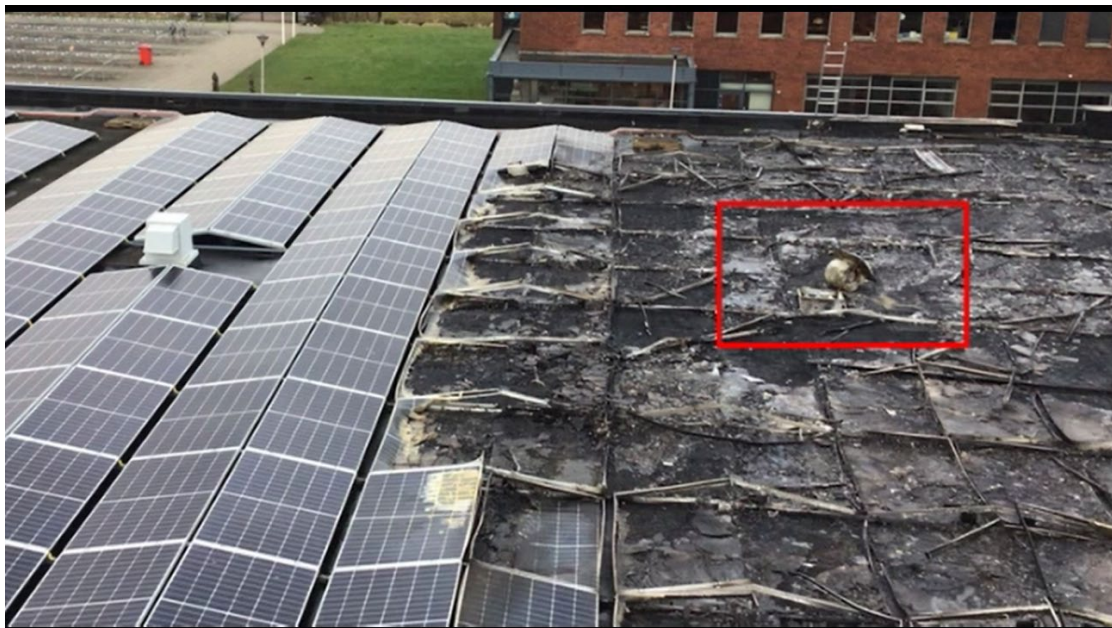
The fire service determined that the fire originated in one of the fans. The plastic casing of the fan then caught fire, causing the fire to spread to the roof surface and the solar panels. Just over a quarter of the area of solar panels was involved in the fire. The fire did not spread inside. However, there is considerable water damage in the sports hall. The sports hall consisted of one fire compartment, so the fire could not spread to another compartment.

Figure 16 The place where the fire started, marked in red, with a similar fan on the left. (Source: Gelderland-Midden Fire Service)

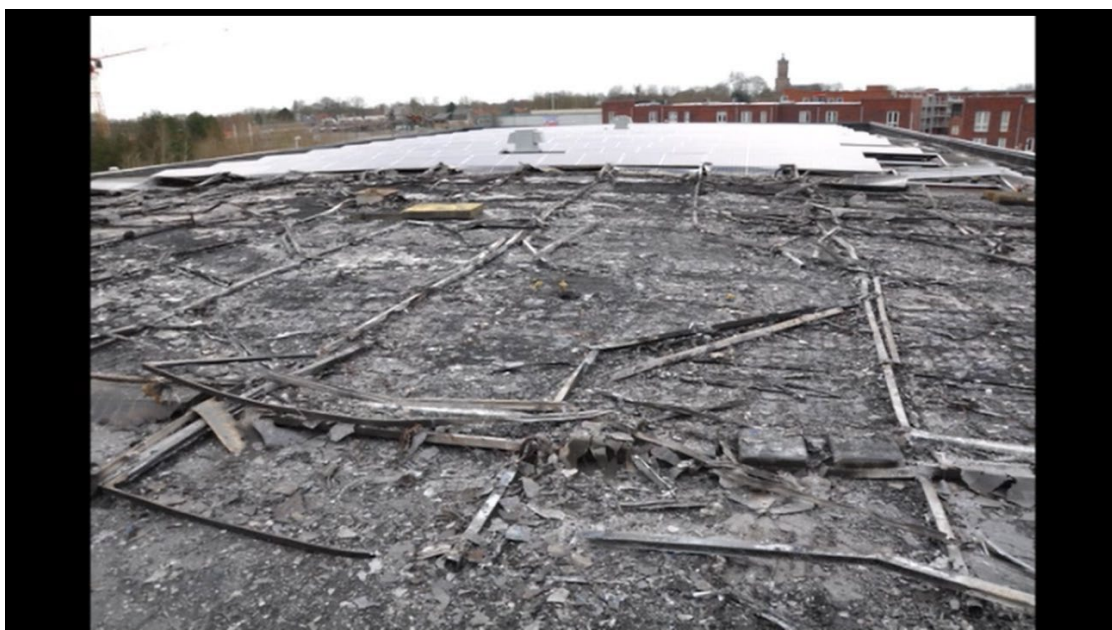
Figure 17 Damage to the PV plant and roof (Source: Gelderland-Midden Fire Brigade)

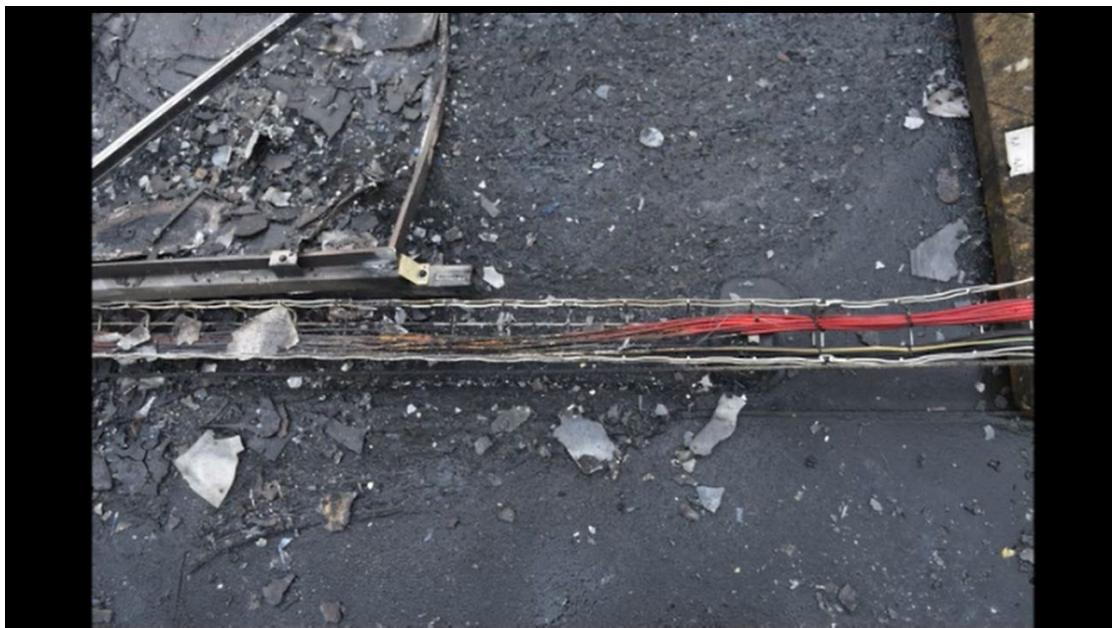
Figure 18 Damage to the cables (Source: Gelderland-Midden Fire Brigade)
